# Amerton News April 2009

## John Strike

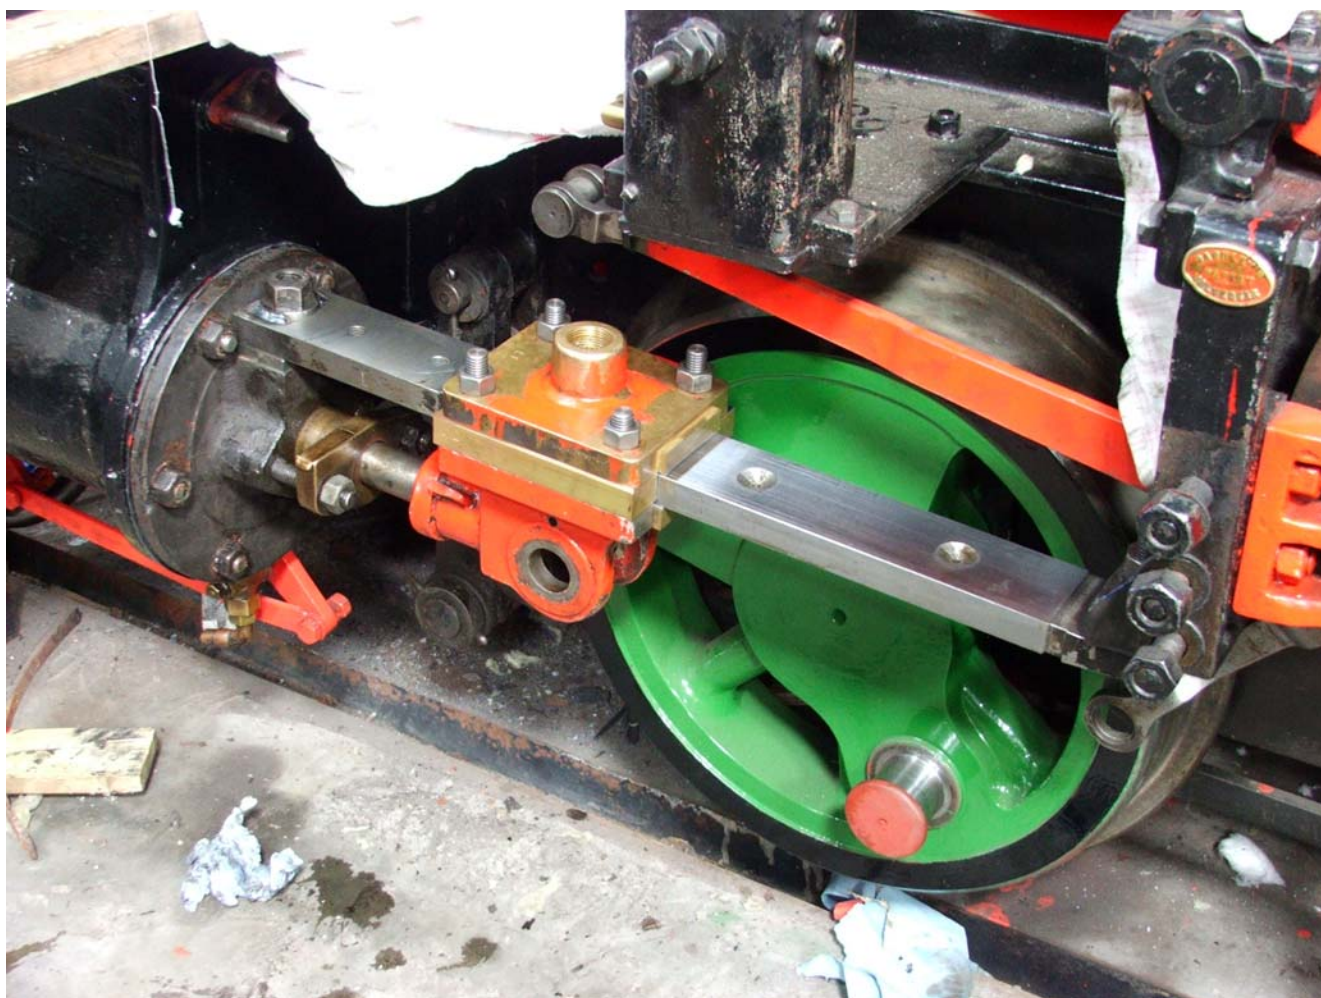
*Isabel's rebuilt cross-head with whitemetal faced bronze slippers top and bottom, surface ground slidebar and new pistons, all installed for the first time, April 2009*

were “forgotten” and have now been rubbed down and painted black and await the visit of the lining out man prior to securing the cladding. The lining man was due to visit in April to do all the lining to the original dimensions recorded by Nick prior to the repainting. The new pistons have been attached to the rods and new cotter pins fitted and the new piston rings have been correctly gapped. We have discovered also that the D-valves are rather worn and these will also have to be built up on the sides with weld and machined back to be a better fit in the steam chest. The face of the valve where the valve rod passes through will also be trued up. Plenty to be going on with.

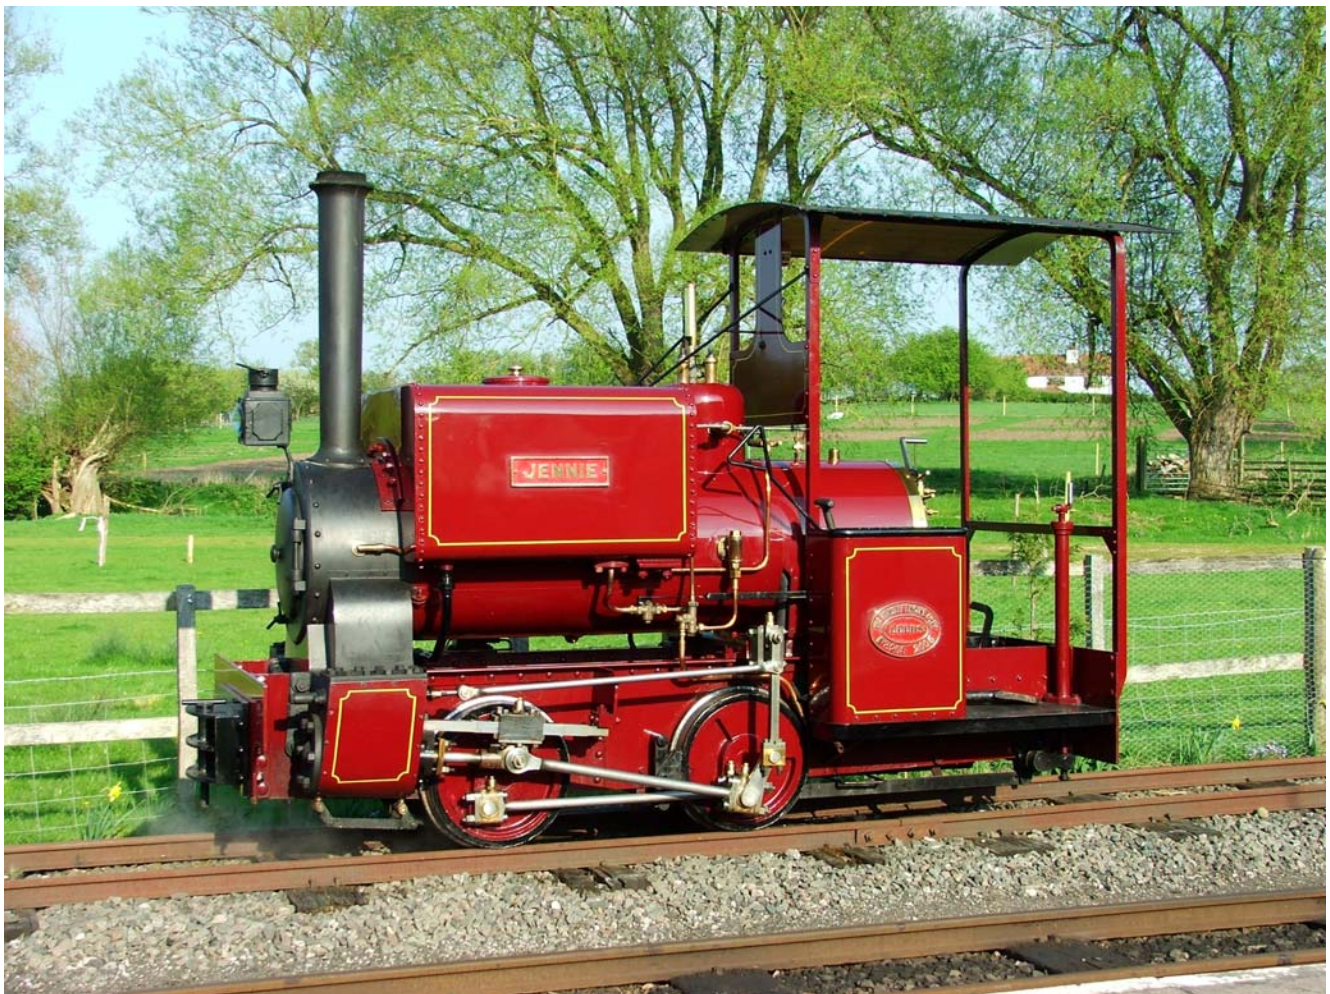
*Jennie basks in the evening sun on 19<sup>th</sup> April 2009 for her official photograph*

*Jennie* has had a new air brake installation completed using our standard fittings, with new pipework and new Rectus self sealing connectors. The hardwood bunker top on the driver's side has been modified and has a hinged section for access to the bunker below. She left the railway on 20<sup>th</sup> March 2009 for a visit to Statfold for their Open Day on the 28<sup>th</sup>. She performed very well on the garden line and the mainline, double headed with O&K 614. Whilst there she was fitted with a blowdown valve and returned to Amerton on 1<sup>st</sup> April 2009 ready to start services over the Easter weekend.

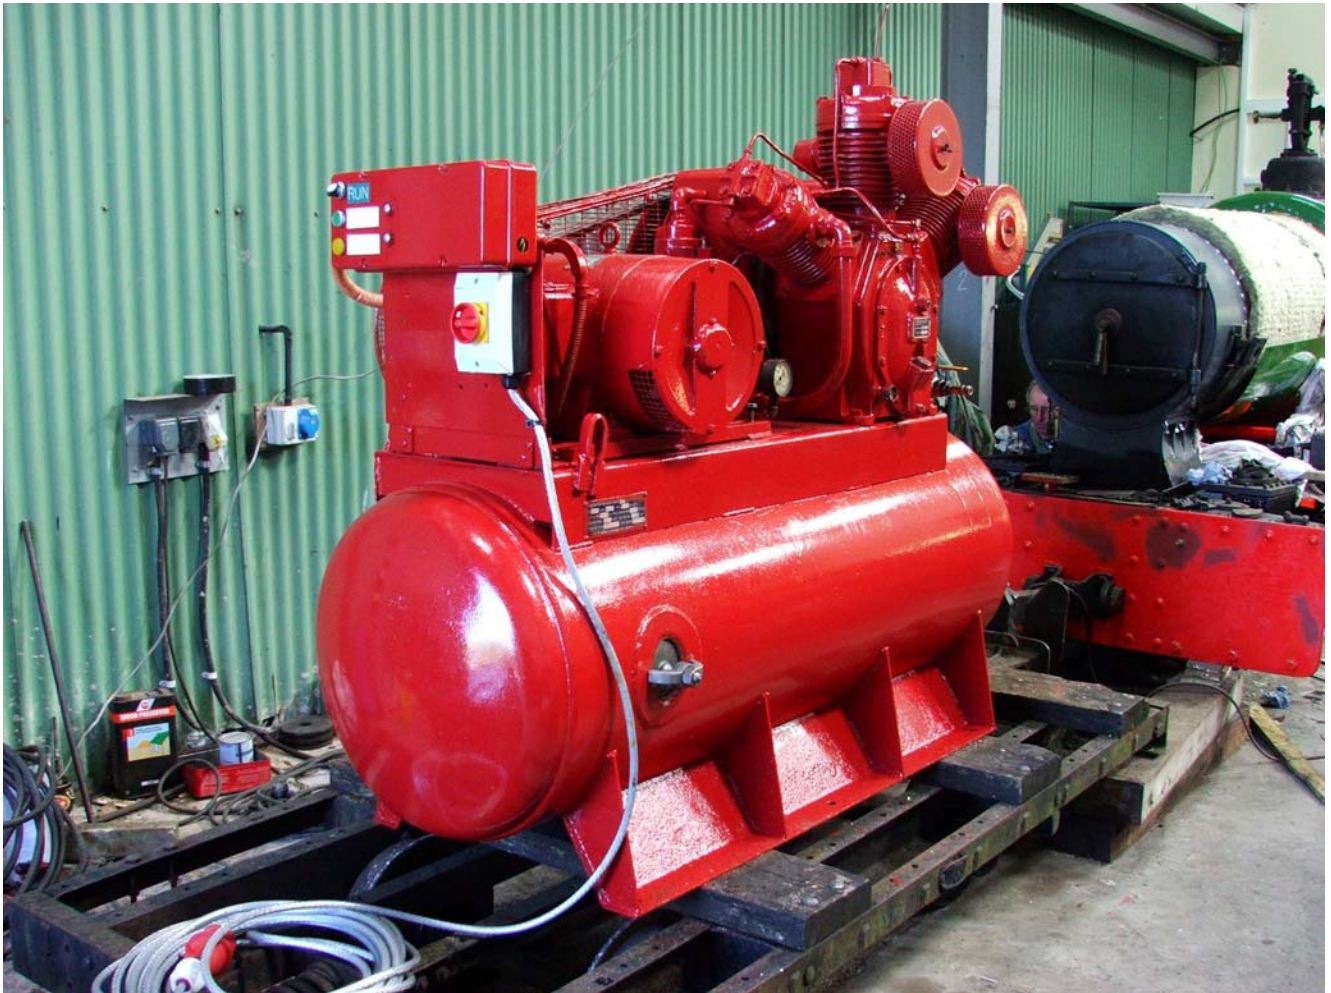
*The completed compressor ready to be installed in the running shed, what a beast!*

The radial arm drill was reassembled and a new drive belt cover fabricated by Terry and fixed to the floor. Pete has continued his PAT testing and re-cabling of our portable electrical equipment to great effect. The new compressor has been stripped down by Pete and Chris and a new oil seal fitted to the main shaft, and the air receiver thoroughly cleaned out. The electrics have been renewed and the whole lot given a coat or two of Monarch gloss. New mud doors and gaskets were obtained and fitted to the original receiver, and a new much larger receiver purchased to increase the capacity for riveting etc. This now awaits installation in the running shed. Steve carried out some minor repairs to the FLT, but currently the machine is stopped pending further work. Unfortunately the Archdale vertical mill suffered a breakage when an insert "dug in" to the work piece. One of the drive gears has broken in half and another has been found to be severely worn. Replacement parts are not available, but a quote of several hundred pounds has been received for the new items, a gear and a gear on a shaft. The machine is in pretty sound condition, so we are likely to proceed.
